EXPERIMENTAL RESEARCH INTO THE RESPONSE OF A MONUMENTAL HISTORIC STRUCTURE TO TRAFFIC-INDUCED EFFECTS OF TECHNICAL SEISMICITY

BASILICA OF THE ASSUMPTION OF OUR LADY IN STARÁ BOLESLAV

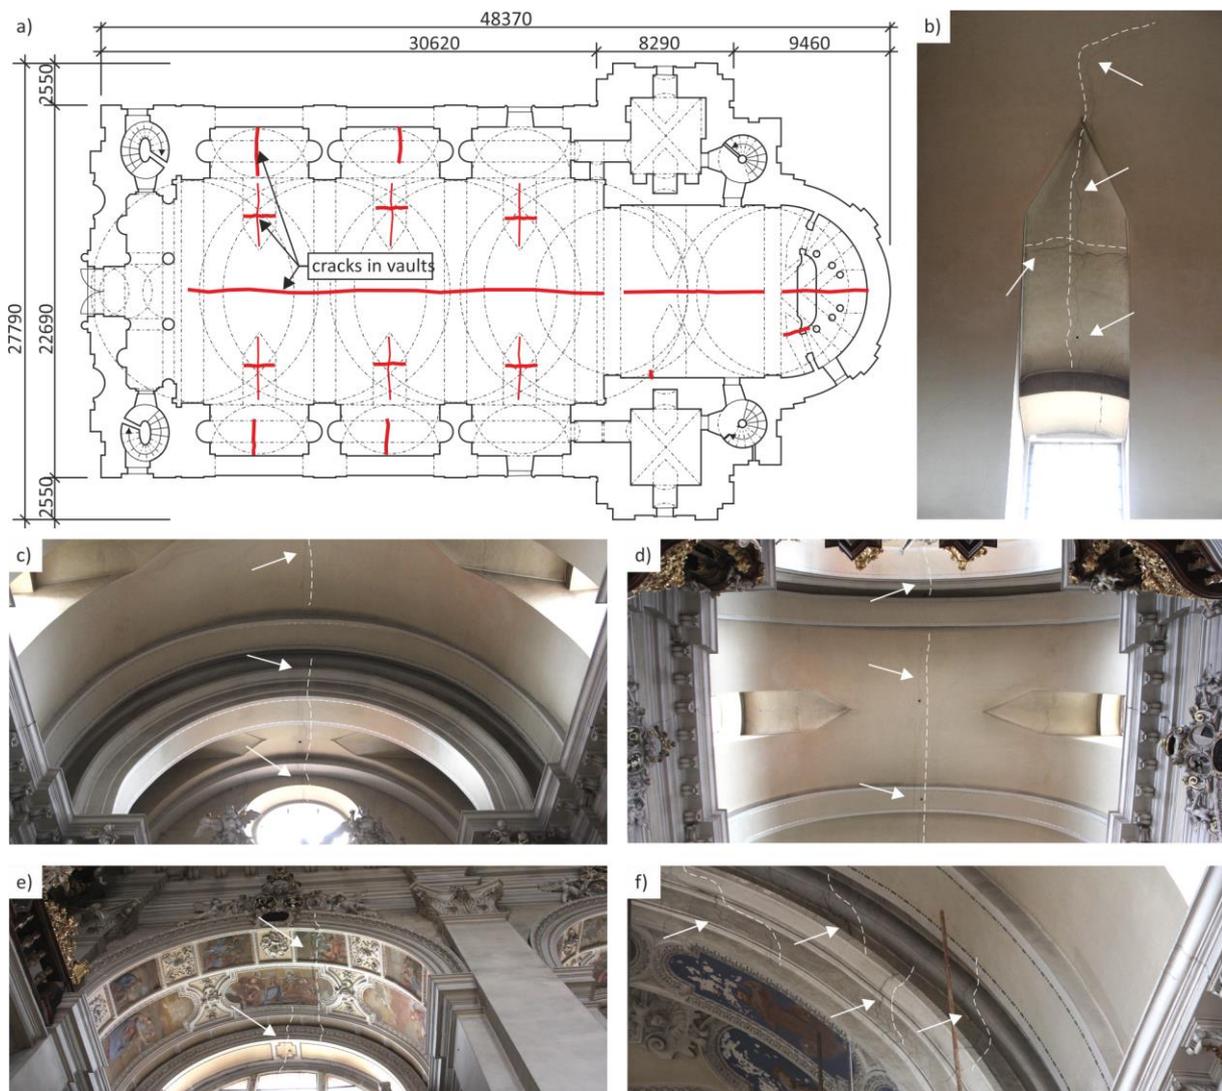
No visually observable cracks were detected in the vertical bearing walls of the perimeter and interior masonry, the masonry of the towers and the pillars. The barrel vault of the main nave and the presbytery is damaged by a longitudinal crack at the vault crown running along the entire length. It is a tensile crack up to 5 mm in width visible in the plaster on the vault face. The vault of the main nave is also damaged by cracks in the springers of barrel vault bay windows running in the same direction. The vaults of longitudinal galleries above the vaults of the main nave side chapels are damaged by cracks perpendicular to the longitudinal axis of the church and located near the main nave lunettes. The barrel vaults of the side chapels are also damaged by cracks at the crowns running in the direction perpendicular to the longitudinal axis of the church (Figure 4).

Fig. 4 - a) Scheme of the church structures' failure, b) Detail of the lunettes' failure, c) Failure of barrel vault and the arch ring at the western façade, d) Longitudinal crack in the main nave's barrel vault, e) Failure of the barrel vault of the side chapels, f) Detail of failure in arch ring footing

Although the experimental measurements of the effect of traffic-induced technical seismicity show that the load-bearing structure of the Basilica is not at risk due to traffic-induced technical seismicity on the adjacent road, it is recommended to take preventive measures to protect the load-bearing structure of the Basilica. It is evident from the type and pattern of cracks on the vaulted system, considering the results of the experimental measurement of the dynamic response [3], that the most likely and the main cause of the existing damage to the barrel vault and arches over the Basilica main nave, the damage to the barrel vault in the springers of bay windows and the vaults of longitudinal galleries above the vaulted spaces of chapels is insufficient absorption of horizontal forces exerted by the barrel vaults. The barrel vaults over the main nave and the adjoining vaults lack visible bowstrings, and horizontal forces – particularly the forces exerted by the effects of the barrel vault with a span of 13.8 m over the main nave – are mostly transferred by the massive structures of the supporting system. The relatively very small horizontal deformations of the supporting system in the order of magnitude of 10^{-3} of the vault span may be the cause of the appearance of tensile stresses at the vault crown, which exceed the vault masonry strength in tension and are the cause of tensile cracks. In the case that a solution with a visible bowstring system cannot be used, the following solution is recommended as the main rehabilitation measure of the existing damage to the vaults:

- execution of vault beam ties at a level above the vaults;
- execution of inclined bowstrings suspended on an additionally mounted stiff girder;
- execution of a prestressed steel strip on the outer curve of the vault made up of prestressed partial segments prestressed by a composite strip (for example according to patent application no. 2018-608 [6]).

To increase the overall efficiency of the proposed solution, it is desirable to prestress the supporting walls of the vaults in the horizontal and vertical direction by prestressed carbon lamellas, or by carbon composite strips fitted in thin horizontal grooves in the area of vault imposts on the outer side of the supporting walls and in thin vertical grooves with anchoring zones at the crown and near the footing bottom of the supporting walls.

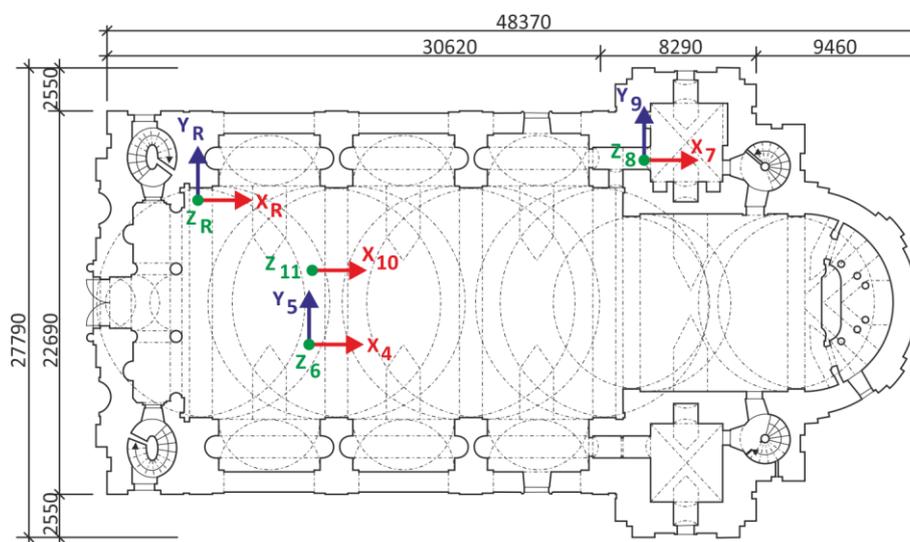
Fig. 5- Diagram of measuring points (accelerometers)

The velocity of movement (oscillation shocks) values at the reference point do not exceed the limit values specified by ČSN 730040. However, at points ACC6, ACC11, ACC4 (on the vault) and at points in the tower, they exceed the limit values, which complies with the note under ČSN 730040 [4]: at points other than the reference point, the oscillation velocity is usually greater. In the case of the response in the tower, where the velocity is by 100% greater than the velocity at the reference point REF, it is necessary to verify the loading by a dynamic calculation using the computational model under ČSN 730040, Art. 5 [4].
